# New York State Department of Transportation

## Yellow Flag NB23U4W006

**BIN: 1065318**

**Feature Carried: 278I278IX2M23027**

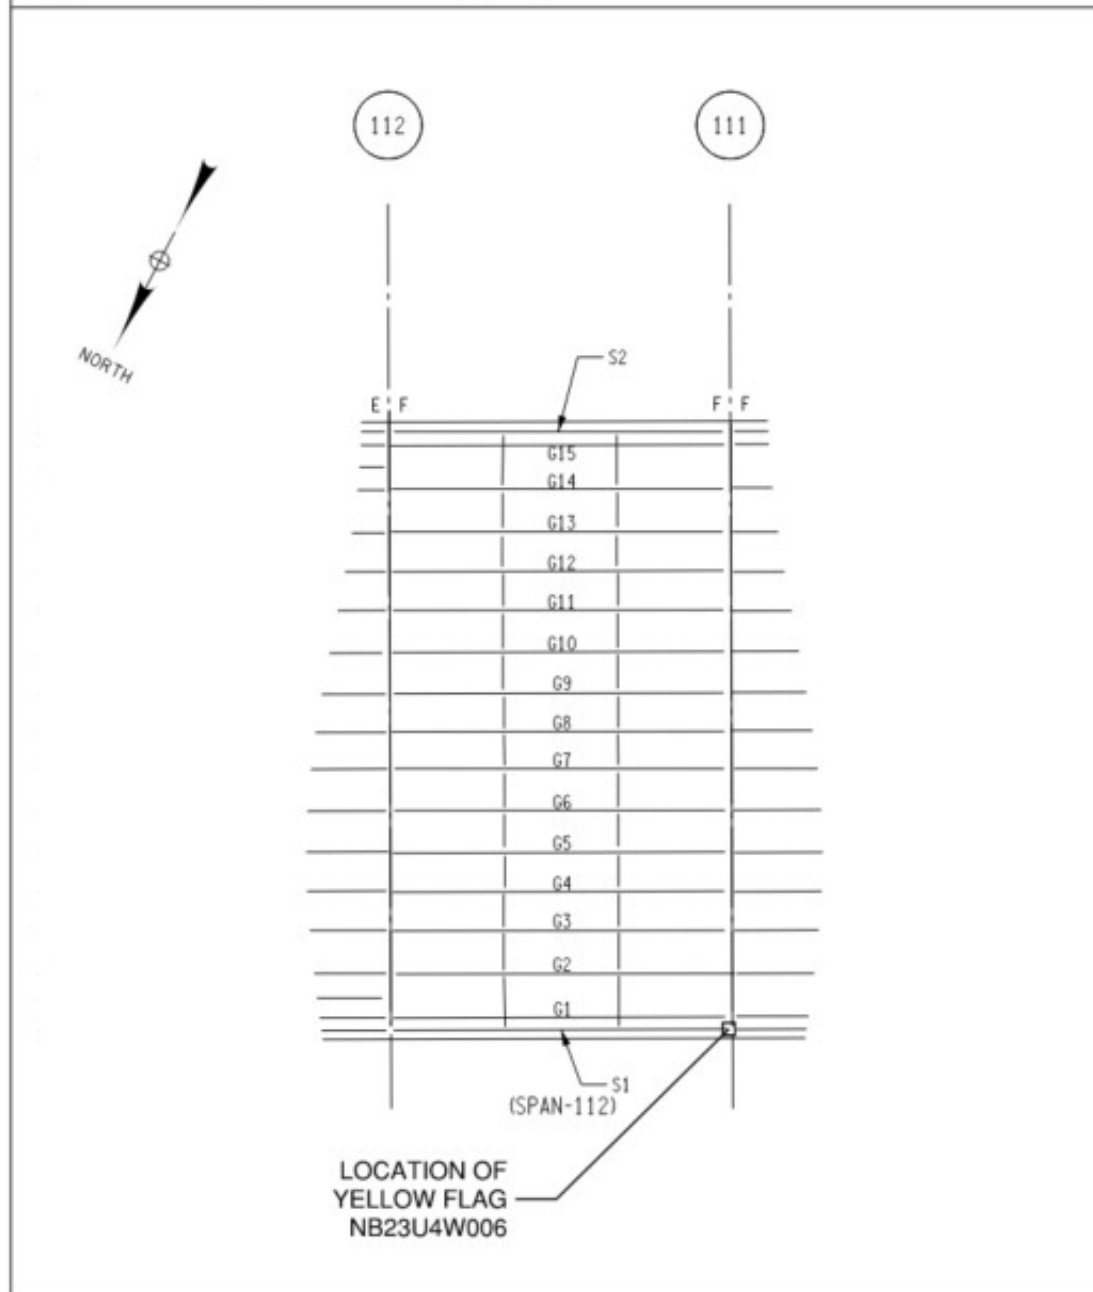
**Attachment Description: Yellow Flag Location Plan**

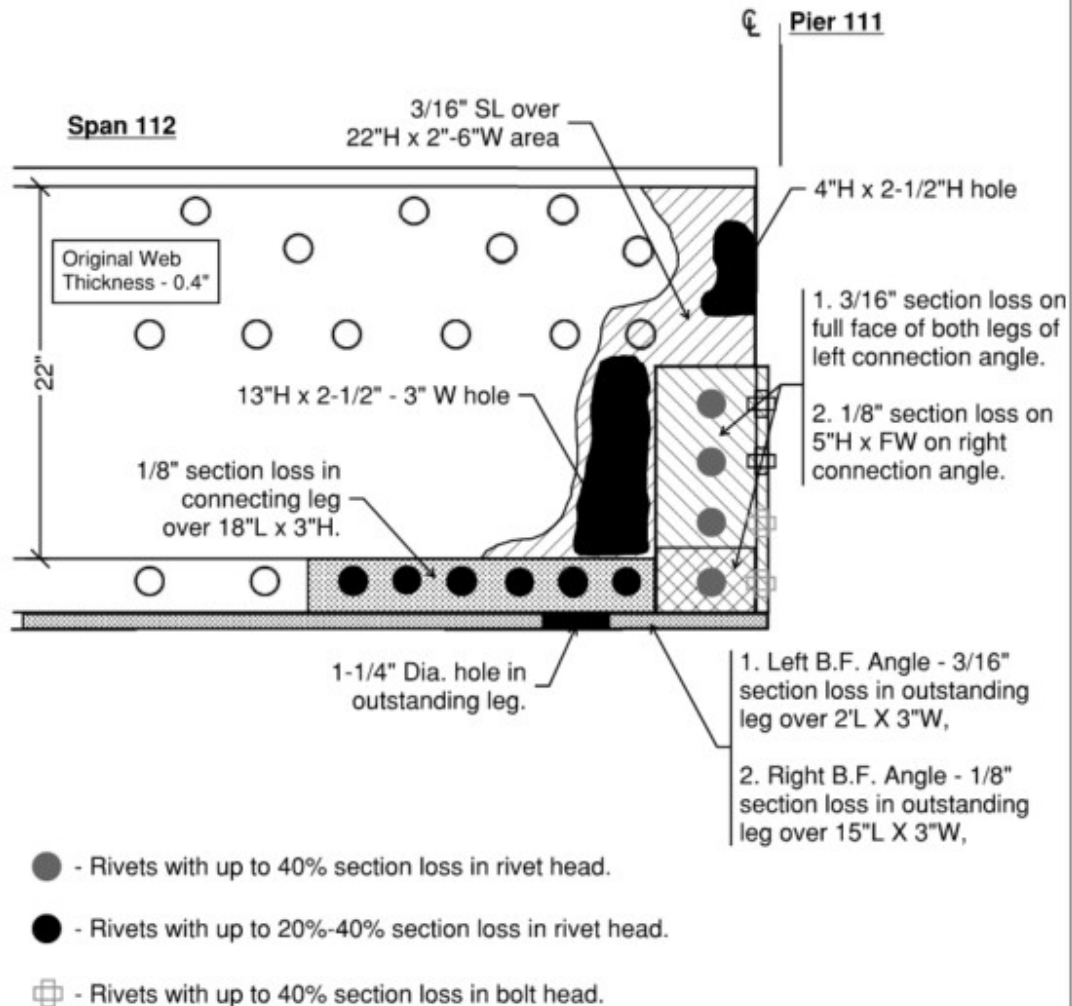
**SKETCH FOR YELLOW FLAG # NB23U4W006**  
**SPAN 112, STRINGER S1 AT PIER 111**  
**(LOOKING RIGHT)**  
**N.T.S**

**Attachment Description: Yellow Flag Condition Sketch**

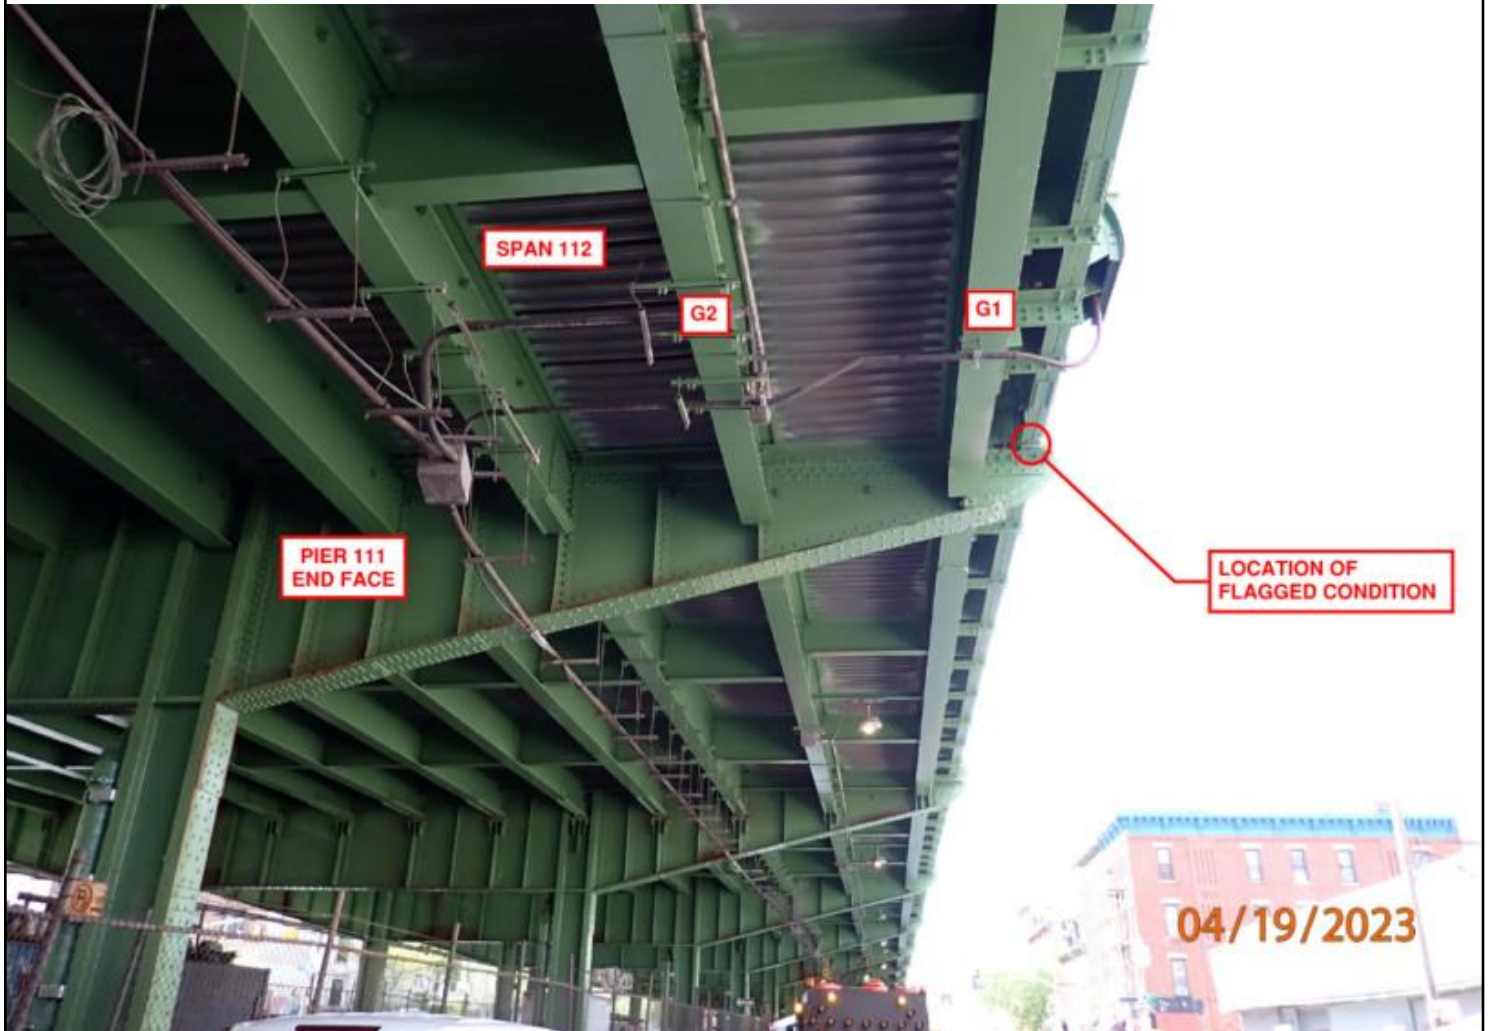
Photo Number: 3

**Attachment Description:** General view of the flagged condition at Stringer S1 in Span 112 at Pier 111. Looking Begin.

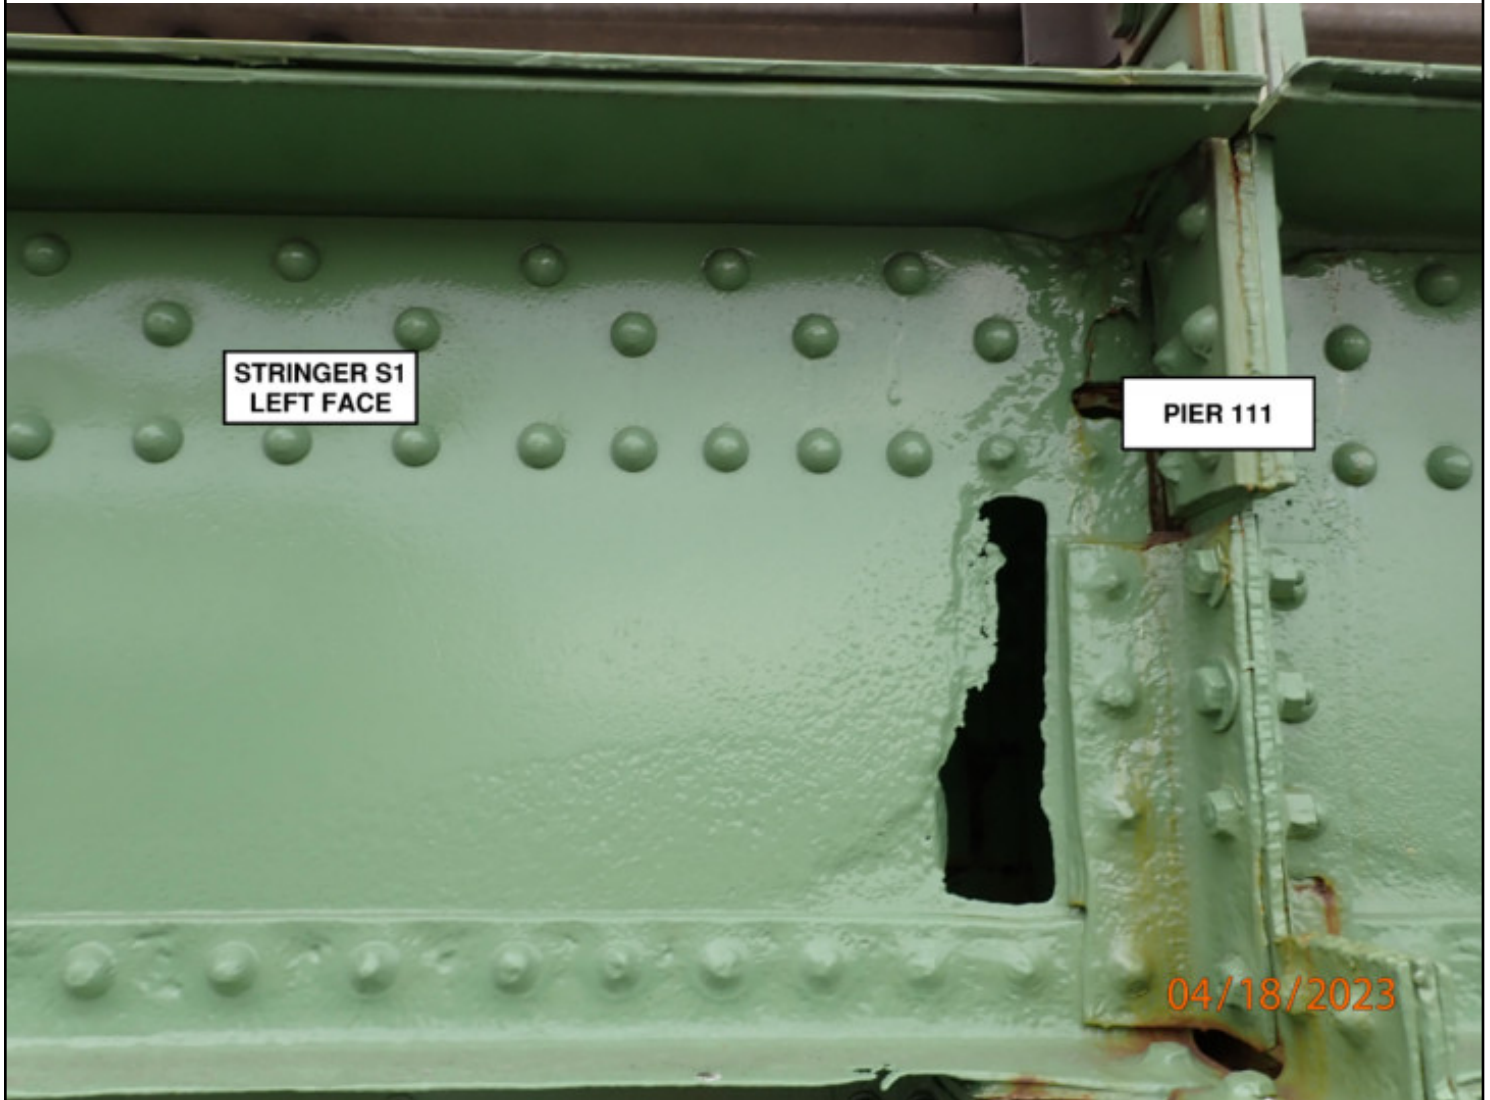
Photo Number: 4

**Attachment Description:** General view of Stringer S1 at the connection to the pier cap of Pier 111. Looking Right.

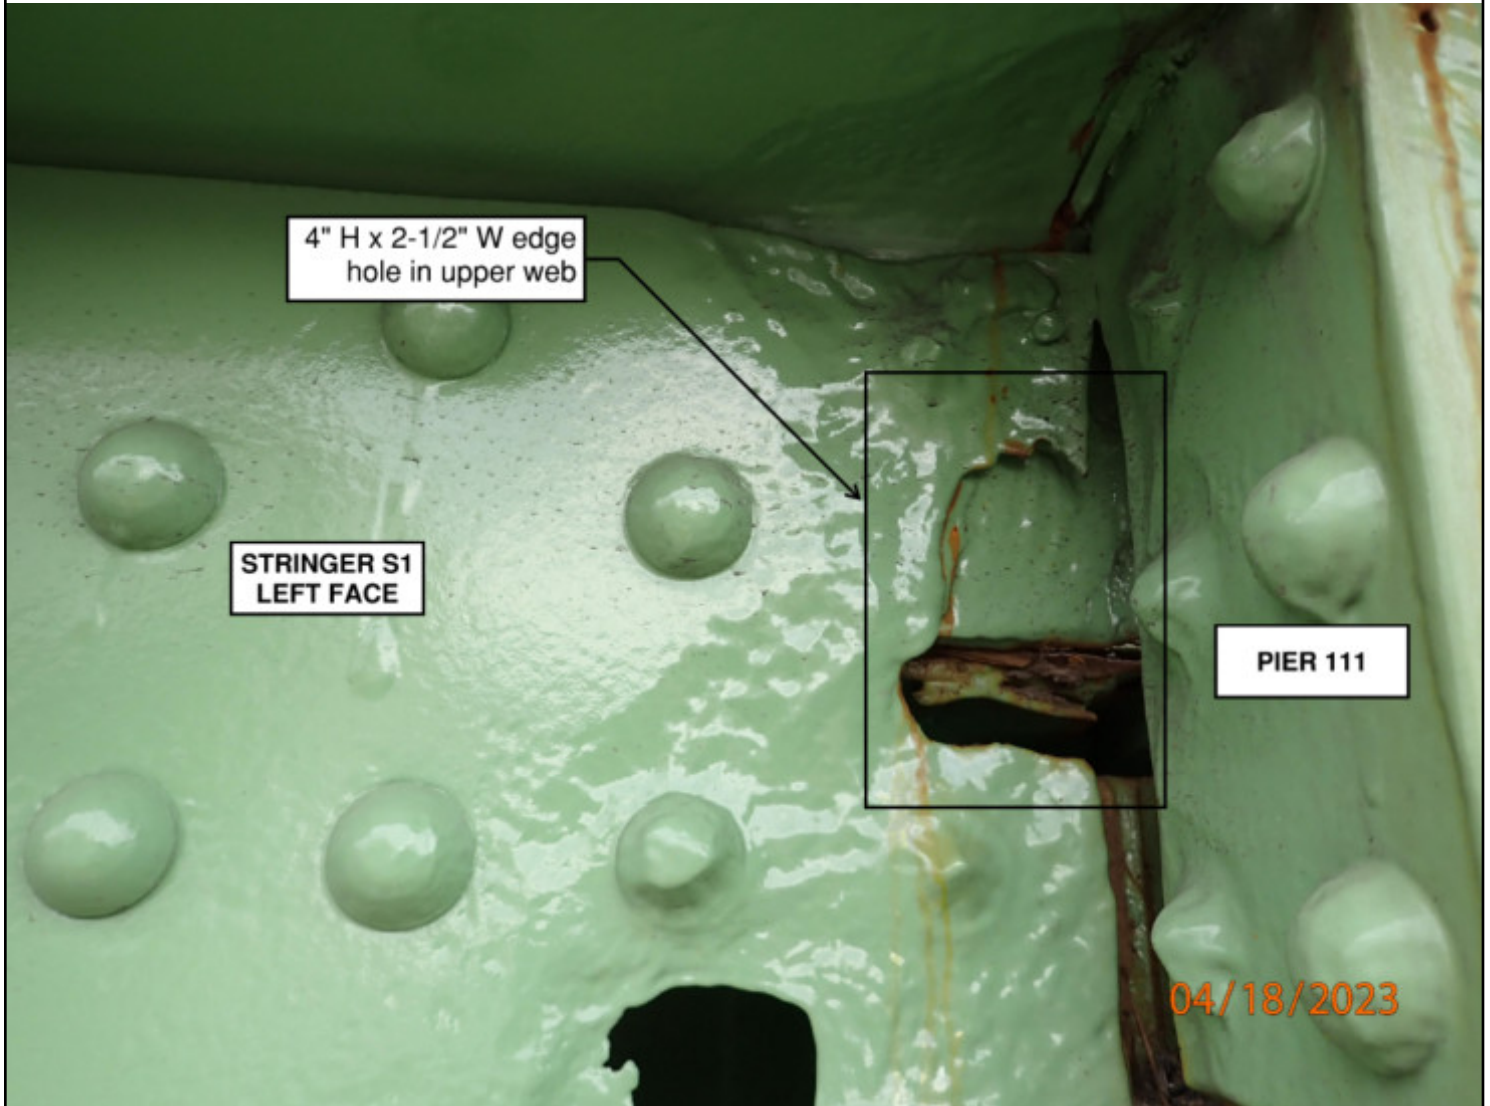
Photo Number: 5

Description: The web at the connection angle of Stringer S1 to Pier 111 has a corrosion hole measuring 4" H x 2 1/2" W at the upper section and a 13" H x 2 1/2"-3" W hole at the lower section and up to 3/16" deep section loss in the surrounding 22" H x 2" - 6" W area (Photo 5 and 6). The left side bottom flange angle has 3/16" D section loss for 3' L x 3" W with a 1 1/4" diameter corrosion hole at the horizontal leg. The vertical leg has 1/8" D section loss for 18" L x 3" H with 20% - 40% section loss at 6 rivet heads. The left side connection angle has up to 3/16" D section loss and 40% section loss at the 4 rivets and 2 bolt heads (Photo 7). The right bottom flange angle has up to 1/8" D section loss for 15" L with a 2" L x 5/8" W corrosion hole at the outstanding leg (Photo 8). The right connection angle has up to 1/8" D section loss at the lower 5" with 30% section loss at the lower 2 connectors (Photo 9).

**Attachment Description:** Close-up view of the edge hole in the web of Stringer S1 at the connection to Pier 111. The upper web has a 4" H x 2-1/2" W edge hole above the connection angle. Looking Begin-Right.

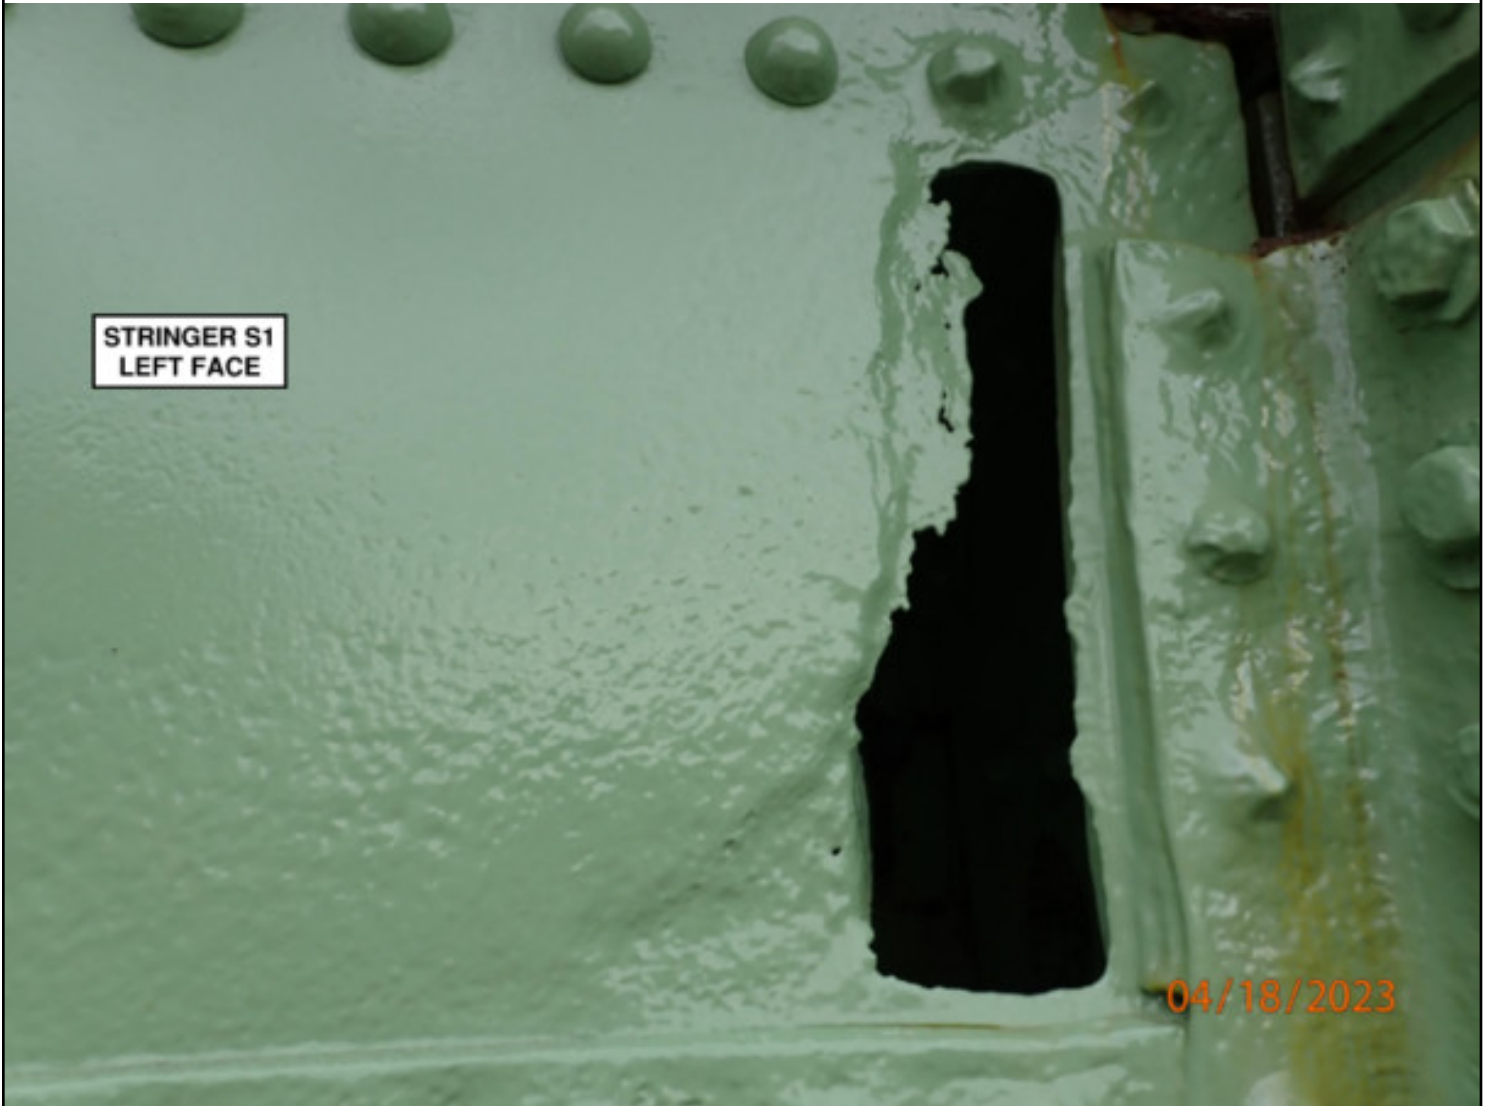
Photo Number: 6

**Attachment Description:** Close-up view of hole in lower web section of Stringer S1 at the connection to Pier 111. The web at the connection angle has a 13" H x 2-1/2" to 3" W hole at the lower section. The surrounding 22" H x 2" - 6" W area has up to 3/16" D section loss. Looking Begin-Right.

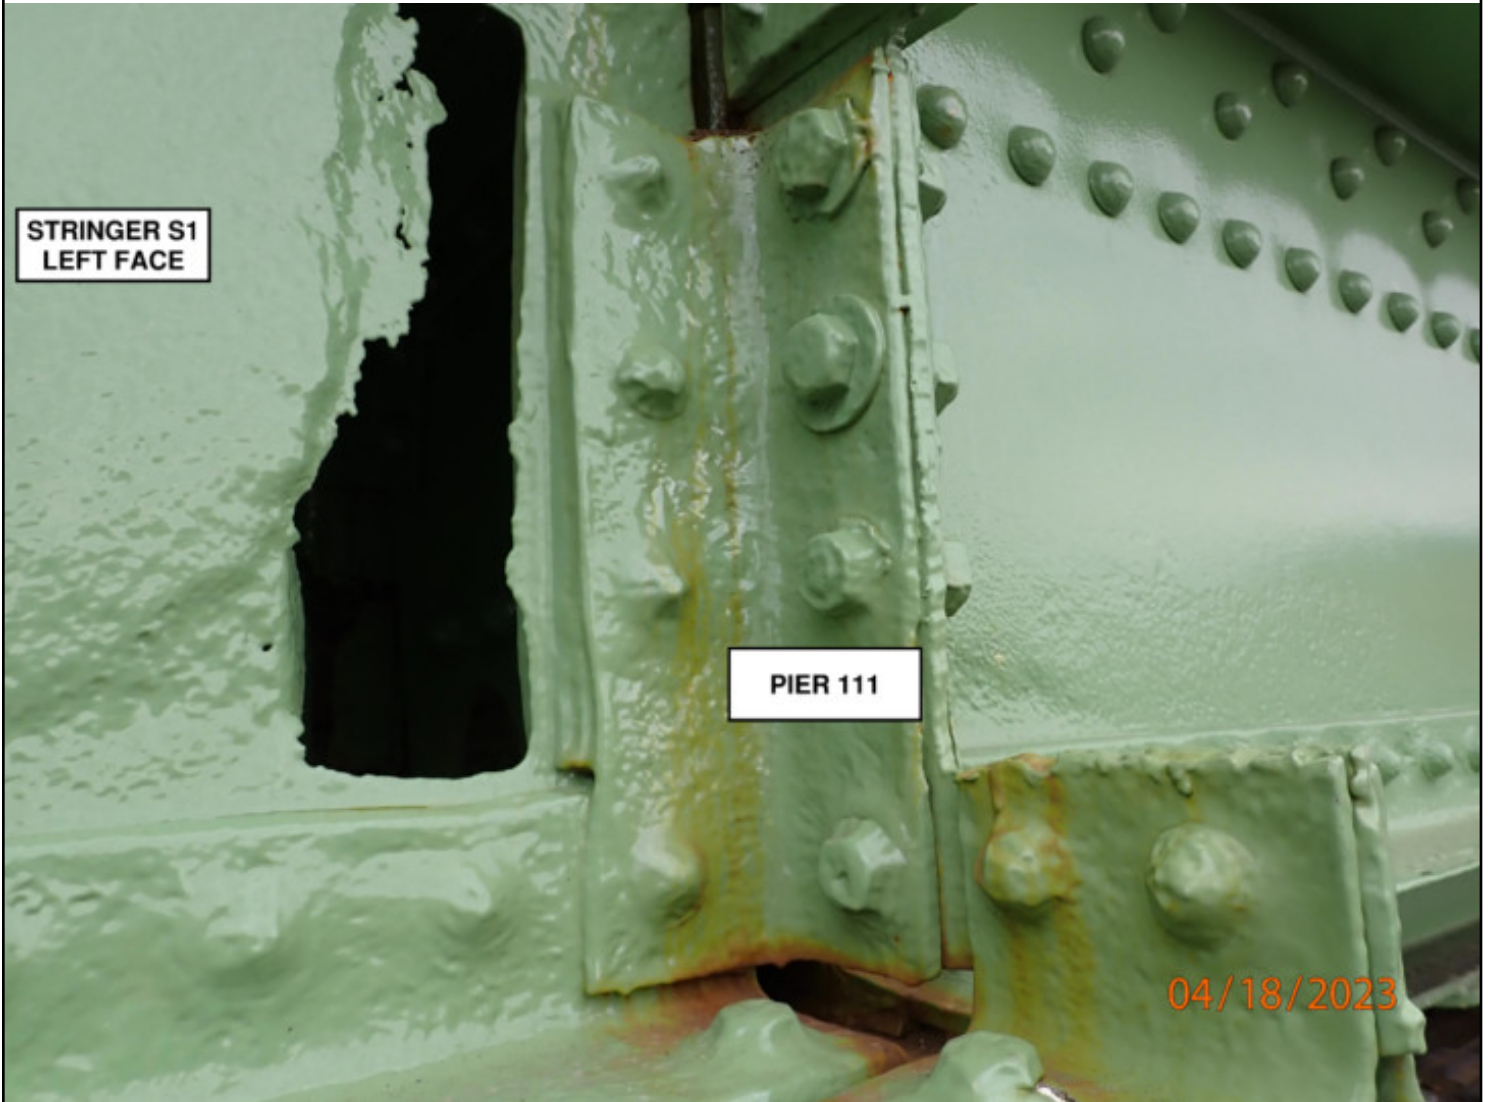
Photo Number: 7

**Attachment Description:** Close-up view of the connection angle of S1 to Pier 111 on the left side. The left side connection angle has up to 3/16" D section loss and 40% section loss at 4 rivets and 2 bolt heads. Looking Begin-Right.

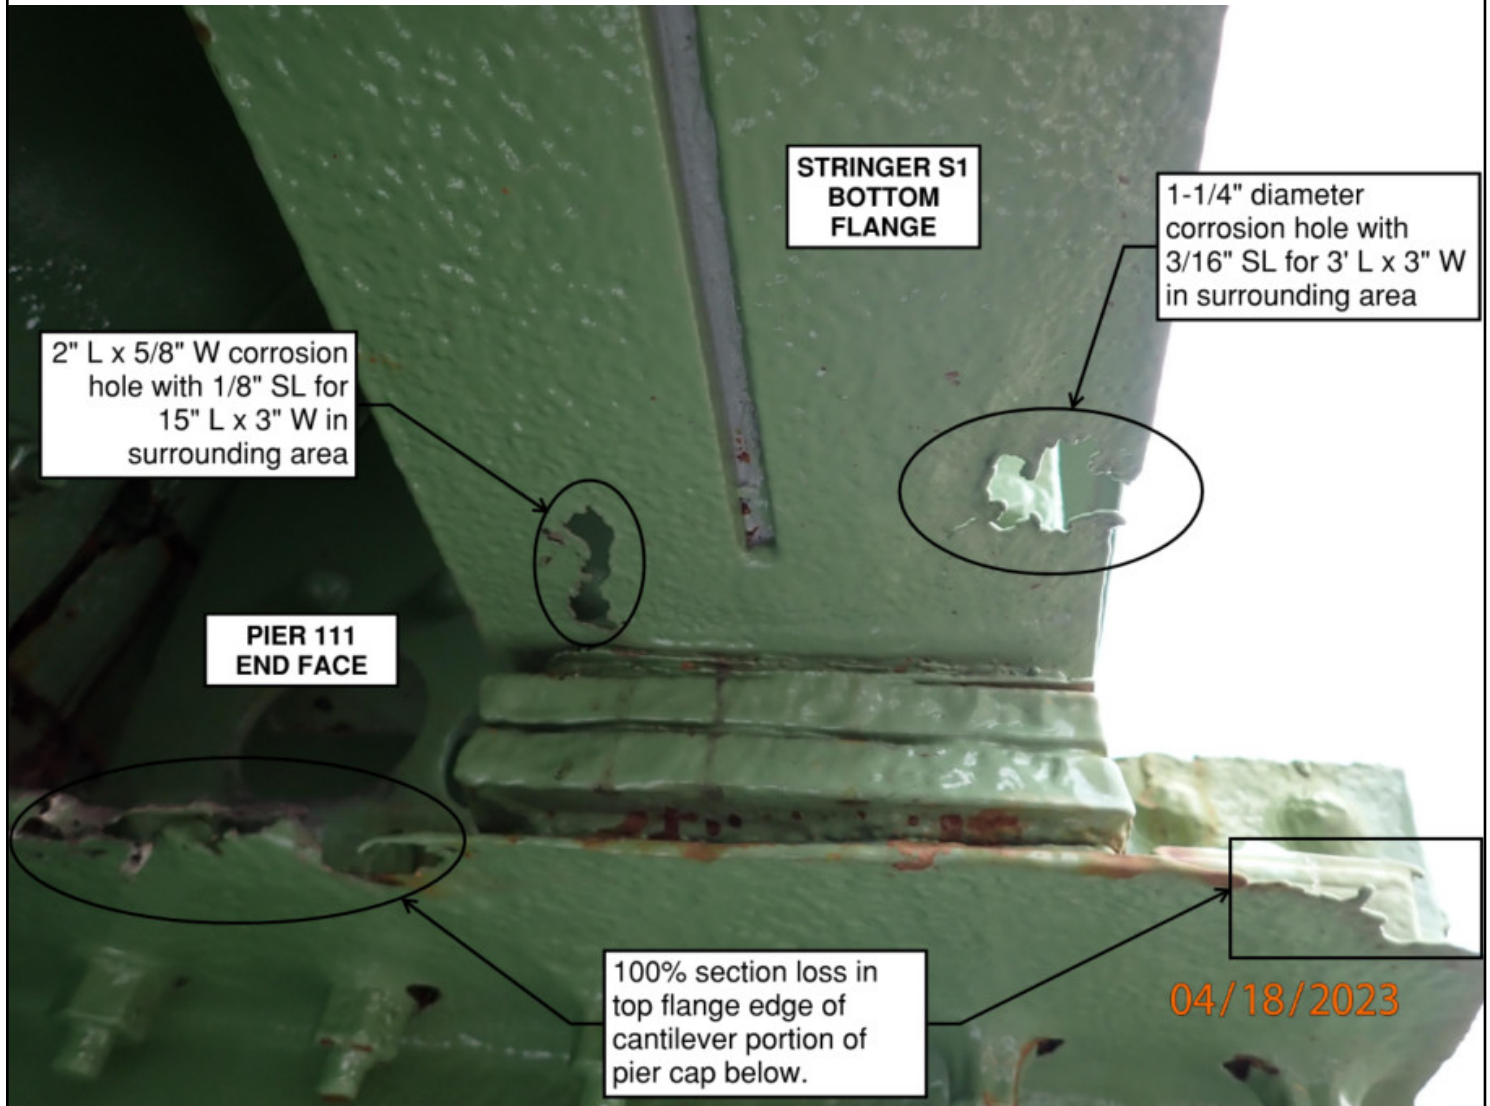
Photo Number: 8

**Attachment Description:** Close up view of bottom flange of Stringer S1 at Pier 111. The left side bottom flange angle has 3/16" D section loss for 3' L x 3" W with a 1 1/4" diameter corrosion hole. The right side bottom flange angle has up to 1/8" D section loss for 15" L with a 2" L x 5/8" W corrosion hole at the horizontal leg. Looking Begin-Up.

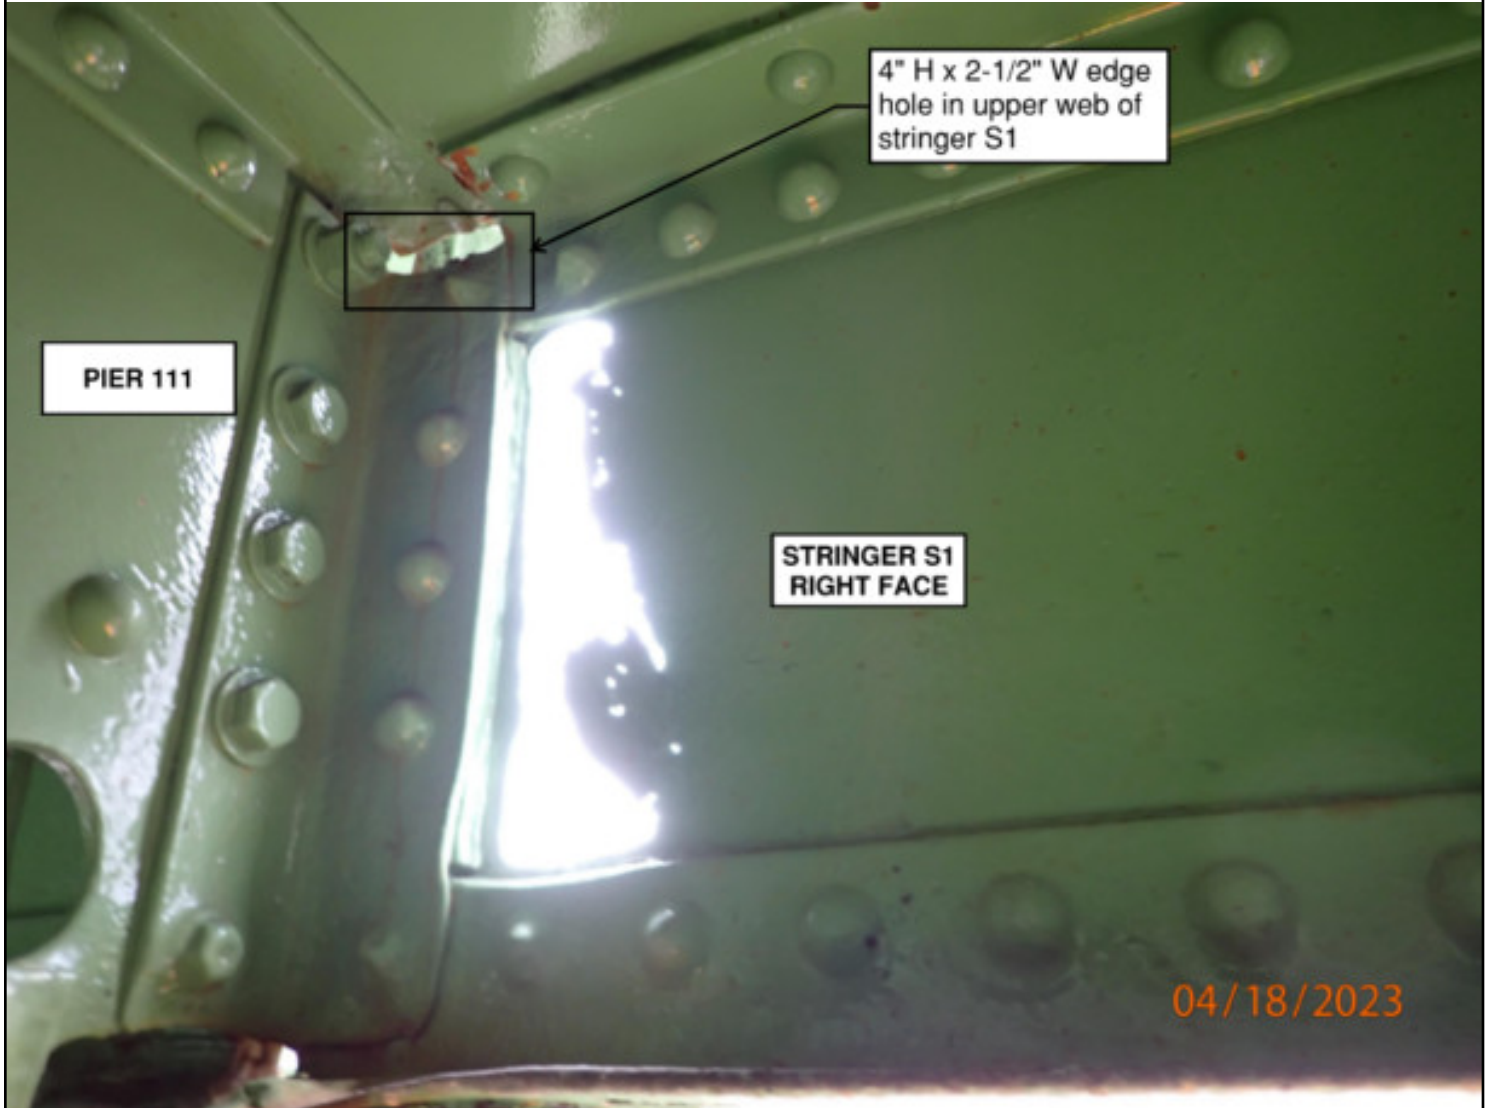
Photo Number: 9

**Attachment Description:** The right bottom flange angle of Stringer S1 at Pier 111 has up to 1/8" D section loss for 15" L with a 2" L x 5/8" W corrosion hole at the horizontal leg. Looking Begin-Left.
